# Bad controller communication with the PC

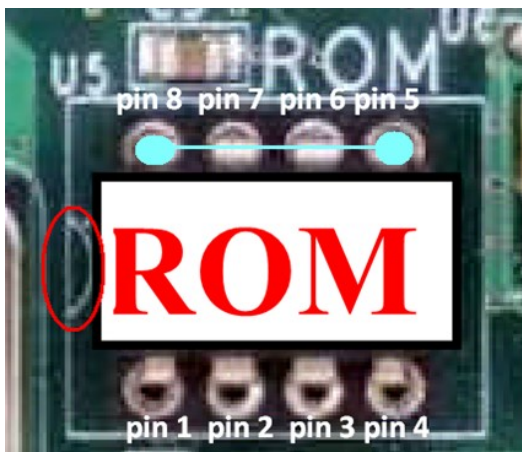
## If the Led still blinks after 2-3 minutes, try to clear the RAM:

- Power off the controller
- Remove the Lithium jumper (JP1)
- On the ROM, shortcut pin 5 with pin 8 together for 5 sec

- Set the JP1 back with the Power
  - Check if the communication is restored
- If not, the controller is faulty - please contact [support@sensoraccess.co.uk](mailto:support@sensoraccess.co.uk)

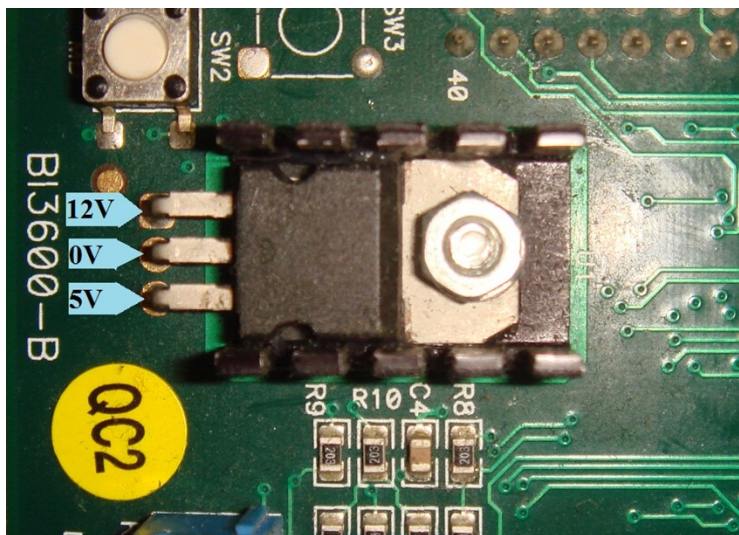
measure the voltage at the regulator located on the board and check that the voltages are close to the following. If not, the board is faulty.

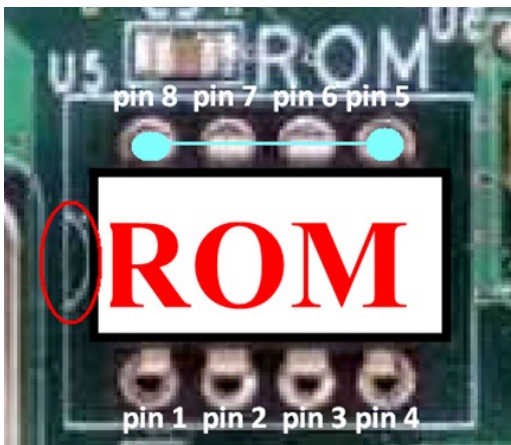
**If the Led still blinks after 2-3 minutes, try to clear the RAM:**

- Power off the controller
- Remove the Lithium jumper (JP1)

On the ROM, shortcut pin 5 with pin 8 together during 5 sec

- Set the JP1 back with the Power
- Check if the communication is restored

If not, the controller is faulty. Contact [support@sensoraccess.co.uk](mailto:support@sensoraccess.co.uk)
